Manhole Inspection Summary

Manhole # S43A2_007MH

Insp Date: **12/19/07 10:33 AM**

Location Address: **1301 Cambria St**

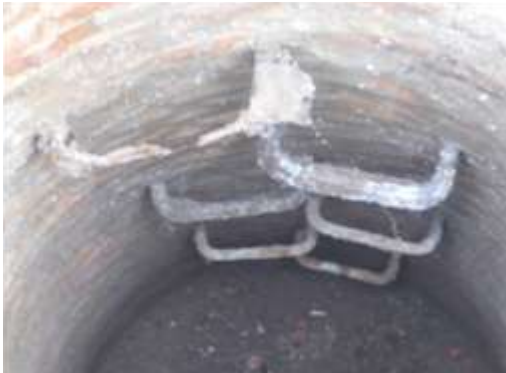
Steps Count: **5** Missing: **1** ☒ **Corroded**

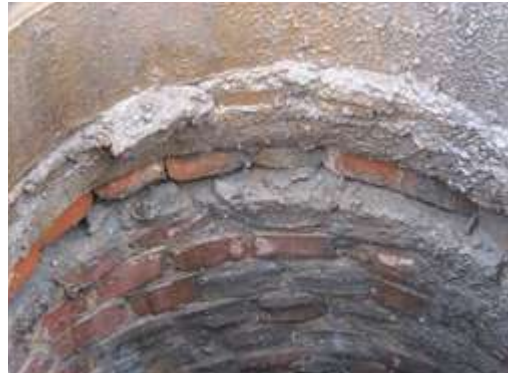
Defect 1

Condition: ☐ Sound ☐ Cracked ☐ Root Intrusion ☒ **Loose Brick** ☐ Deteriorated

Infiltration: ☐ None ☒ **Joint** ☐ Cracks ☒ **Mortar** ☐ Roots ☐ Wall

Infiltration

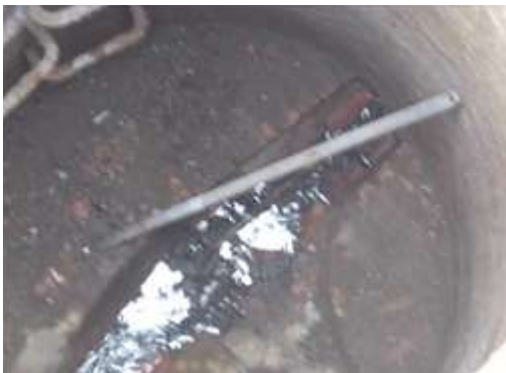
Defect 2

Pole

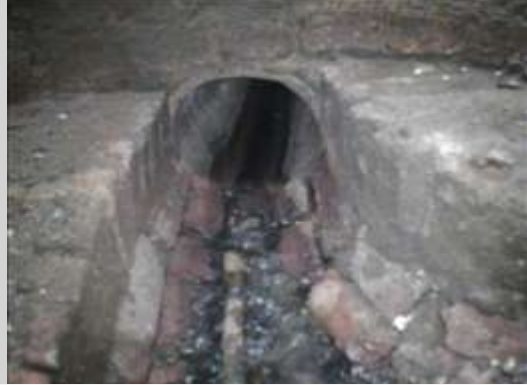
12 O'Clock Outflow

8 in. Circular Gravity Sewer
Pipe Out @ 12 O'Clock

Pipe Height: **9.6** (in.) Rod and Bar (Angled)
Pipe Material: **Clay** ☐ Pipe Lined
Invert Depth: **12.87** (ft.) Flow Characteristics: **Slow**
Deposits: ☒ None ☐ Mud ☐ Sludge ☐ Debris ☐ Grease
Silt Depth: (in.) Deposits Extent:
Infiltration: **None** Pipe Seal Cond: **Sound**

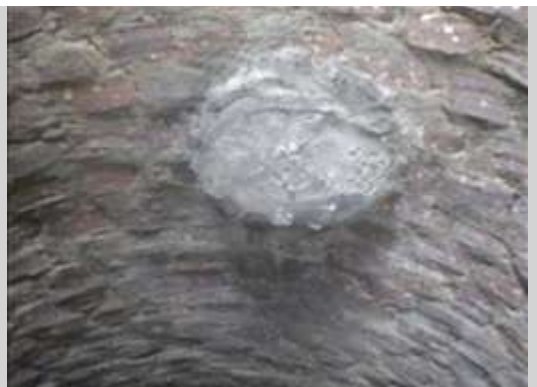
3 O'Clock Inflow

4 in. Circular Gravity Sewer
Pipe In @ 3 O'Clock

Pipe Height: **3.6** (in.) Rod and Bar (Angled)
Pipe Material: **Clay** ☐ Pipe Lined
Invert Depth: **2.00** (ft.) Flow Characteristics: **None**
Deposits: ☒ None ☐ Mud ☐ Sludge ☐ Debris ☐ Grease
Silt Depth: (in.) Deposits Extent:
Infiltration: **None** Pipe Seal Cond: **Unknown**

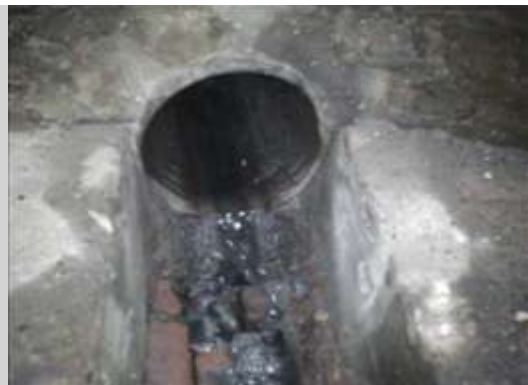
6 O'Clock Inflow

8 in. Circular Gravity Sewer

Pipe In @ 6 O'Clock

Invert Depth: **12.41** (ft.) Flow Characteristics: **Slow**

Infiltration: **None** Pipe Seal Cond: **Sound**
